Technical Hotline Hint

Release **01/05**
Issue Date: 3 March, 2005

Subject: BA Falcon/ SX Territory Auxiliary Audio input

Models: BA Falcon/BA Fairlane/SX Territory

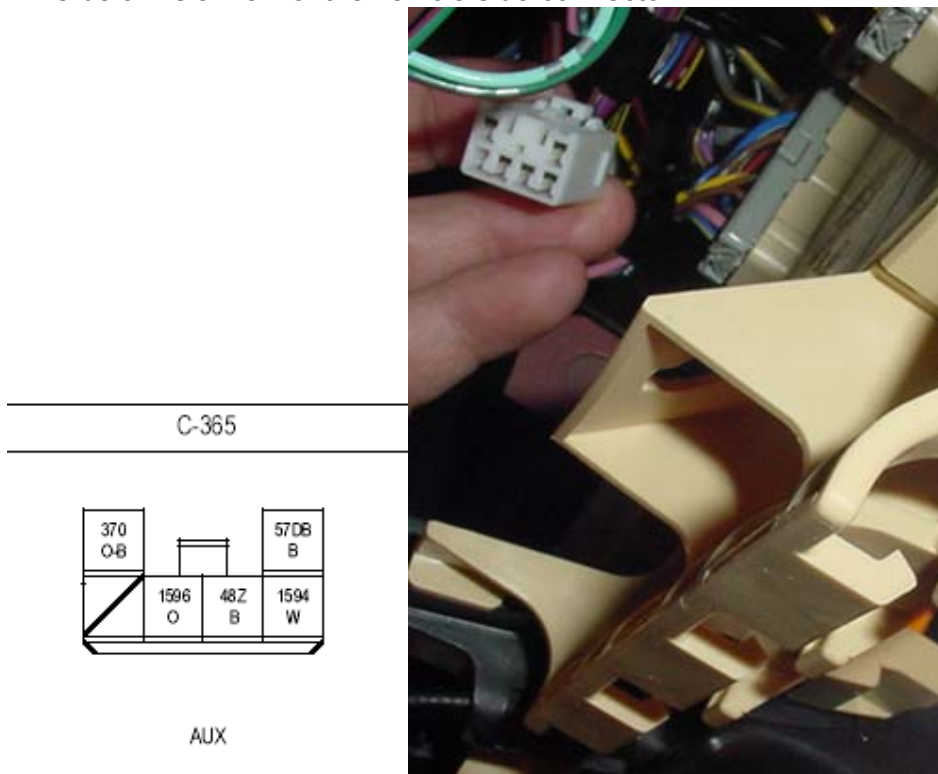
Note: Circuits 370 and 57 are already connected so when the splicing is done there will be 3 circuits connected 370, 57 and 48.

*The below is a view of the vehicle side connector.

- 1) Locate the C365 connector (around fuse panel area) to find the circuits as per the image below.
- 2) Locate the auxiliary loom side of the C365 connector **NOT THE VEHICLE LOOM SIDE.**
- 3) Connect the 2 grounds by splicing the wiring together in the **auxiliary loom plug** which connects to the vehicle wiring. Circuit 57 connects to circuit 48 in connector C-365.
- 4) Check the system for correct operation and reduction in interference/noise.
